# Tracy Fish Facility Studies California

## Hydraulic Performance Evaluation of the Replacement Primary Bypass Intakes and Transition Boxes at Tracy Fish Collection Facility

Volume 40

July 2007

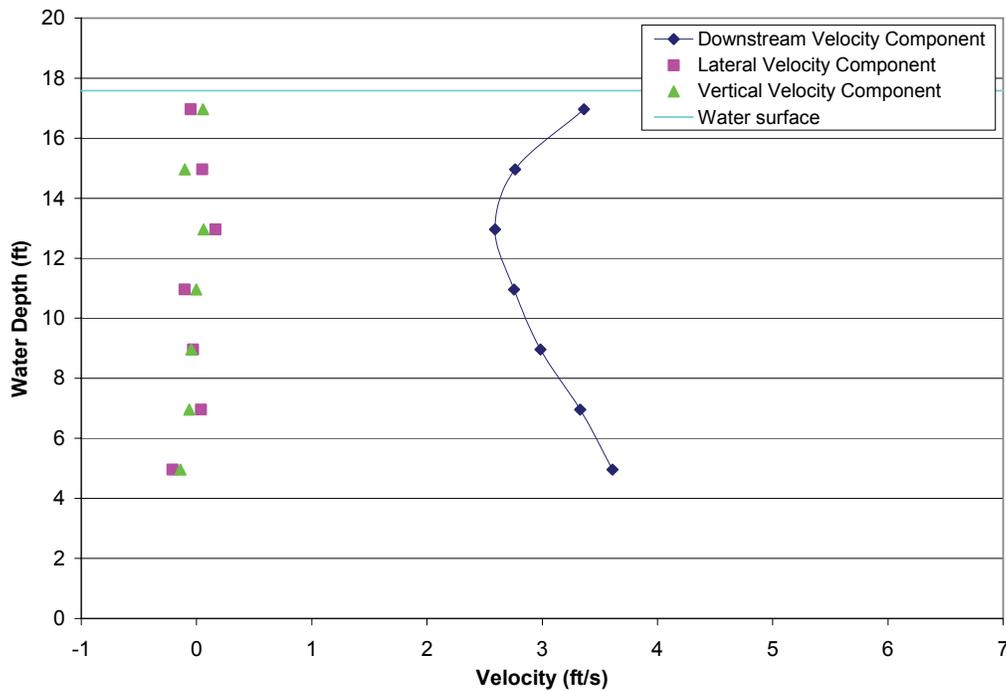
FIGURE A2-1.—Test 2-1, bypass 1 intake profile with all bypasses open, measured bypass ratio = N/A, bypass ratio with facility instruments = 0.86, high tide, water depth = 17.59 ft, trashrack differential = 0.76 ft, louvers differential = 0.72 ft.

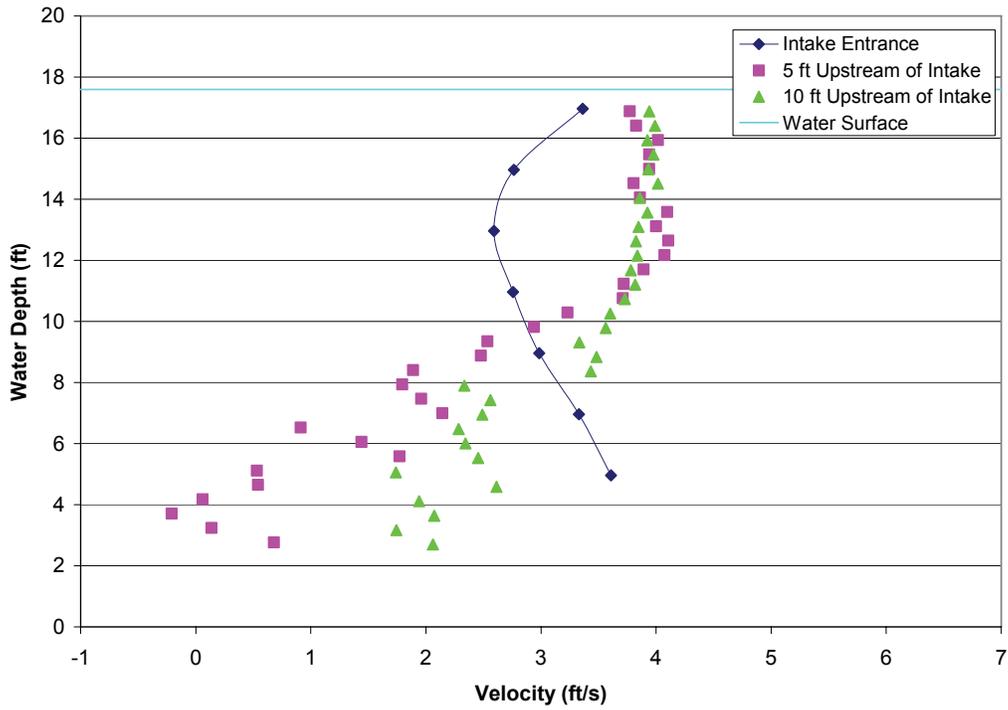
FIGURE A2-2.—Test 2-1, bypass 1 approach velocity profiles with all bypasses open, measured bypass ratio = N/A, bypass ratio with facility instruments = 0.86, high tide, water depth = 17.59 ft, trashrack differential = 0.76 ft, louvers differential = 0.72 ft.

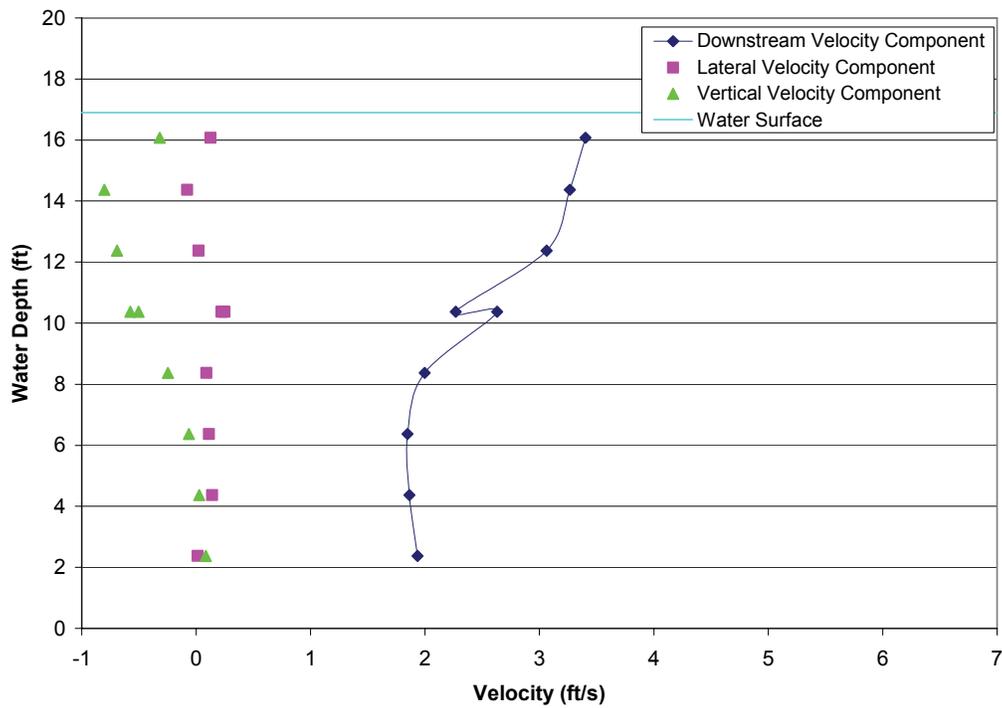
FIGURE A2-3.—Test 2-2, bypass 2 intake profile with all bypasses open, measured bypass ratio = 0.95, bypass ratio with facility instruments = 0.68, outgoing tide, water depth = 16.90 ft, trashrack differential = 1.45 ft, louvers differential = 0.73 ft.

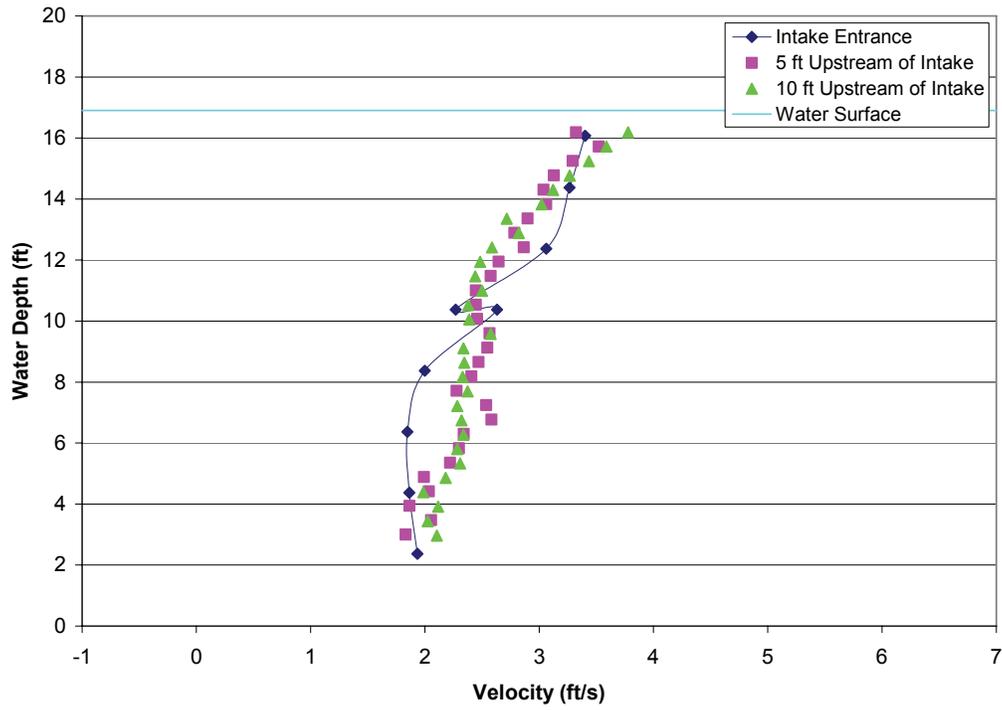
FIGURE A2-4.—Test 2-2, bypass 2 approach velocity profiles with all bypasses open, measured bypass ratio = 0.95, bypass ratio with facility instruments = 0.68, outgoing tide, water depth = 16.90 ft, trashrack differential = 1.45 ft, louvers differential = 0.73 ft.

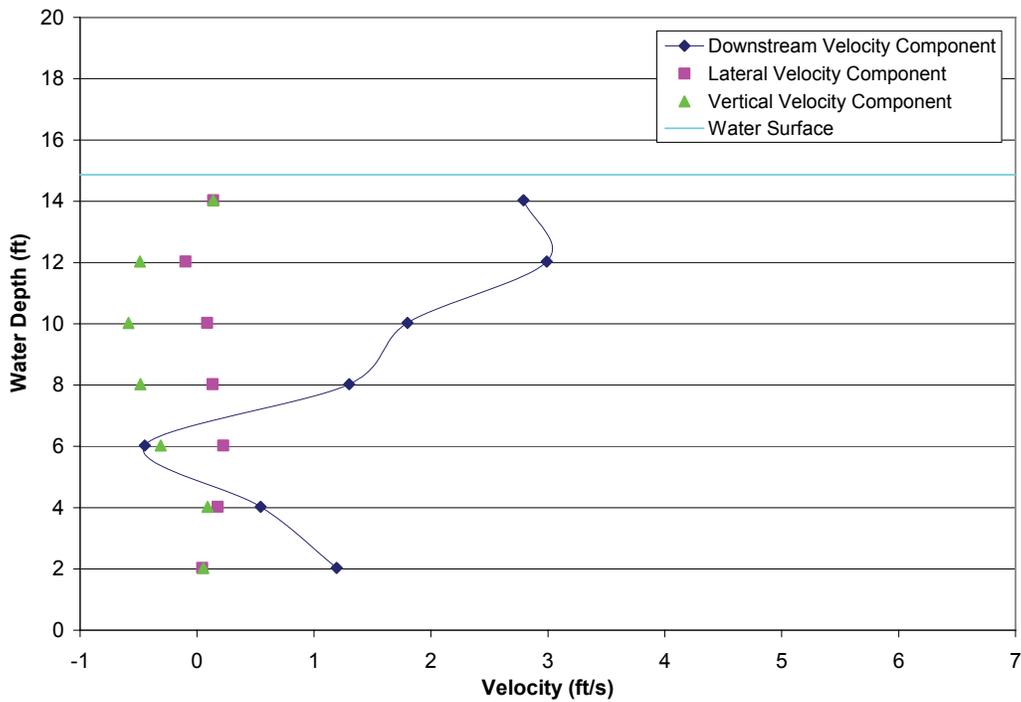
FIGURE A2-5.—Test 2-3, bypass 3 intake profile with all bypasses open, measured bypass ratio = 0.69, bypass ratio with facility instruments = N/A, outgoing tide, water depth = 14.86 ft, trashrack differential = 3.03 ft, louvers differential = 0.74 ft.

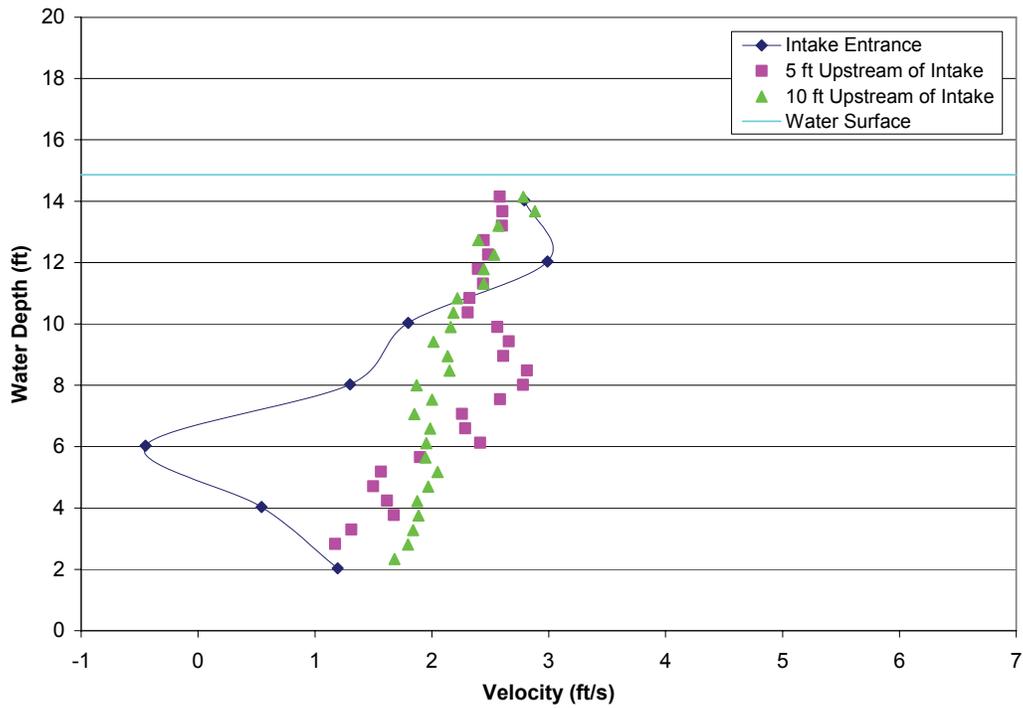
FIGURE A2-6.—Test 2-3, bypass 3 approach velocity profiles with all bypasses open, measured bypass ratio = 0.69, bypass ratio with facility instruments = N/A, outgoing tide, water depth = 14.86 ft, trashrack differential = 3.03 ft, louvers differential = 0.74 ft.

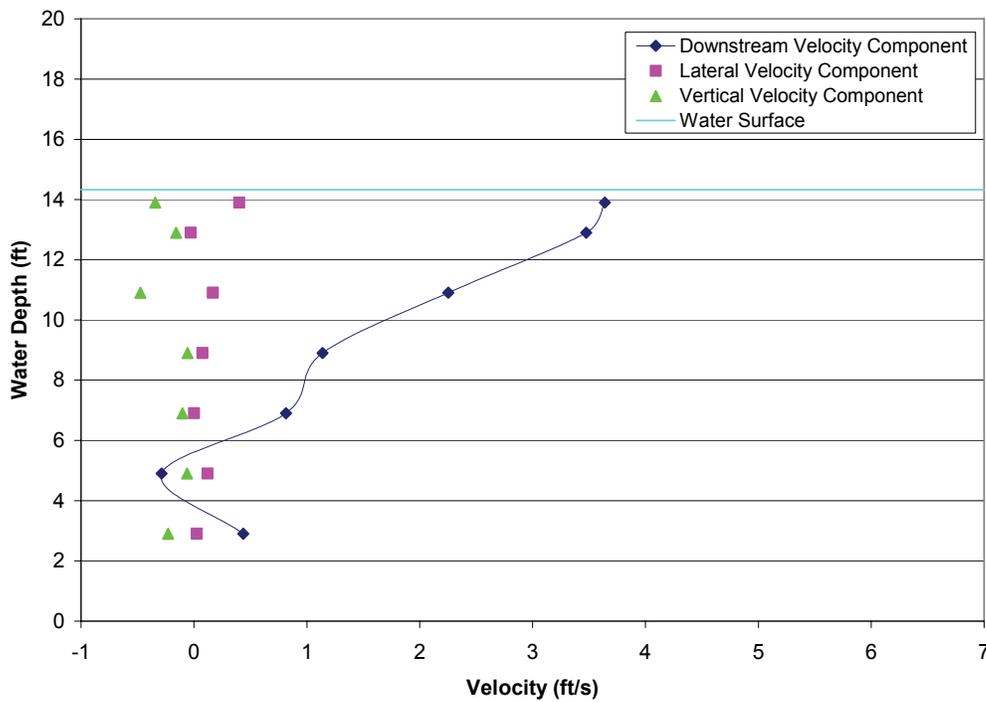
FIGURE A2-7.—Test 2-4, bypass 4 intake profile with all bypasses open, measured bypass ratio = 0.37, bypass ratio with facility instruments = N/A, outgoing tide, water depth = 14.33 ft, trashrack differential = 2.98 ft, louvers differential = 1.19 ft.

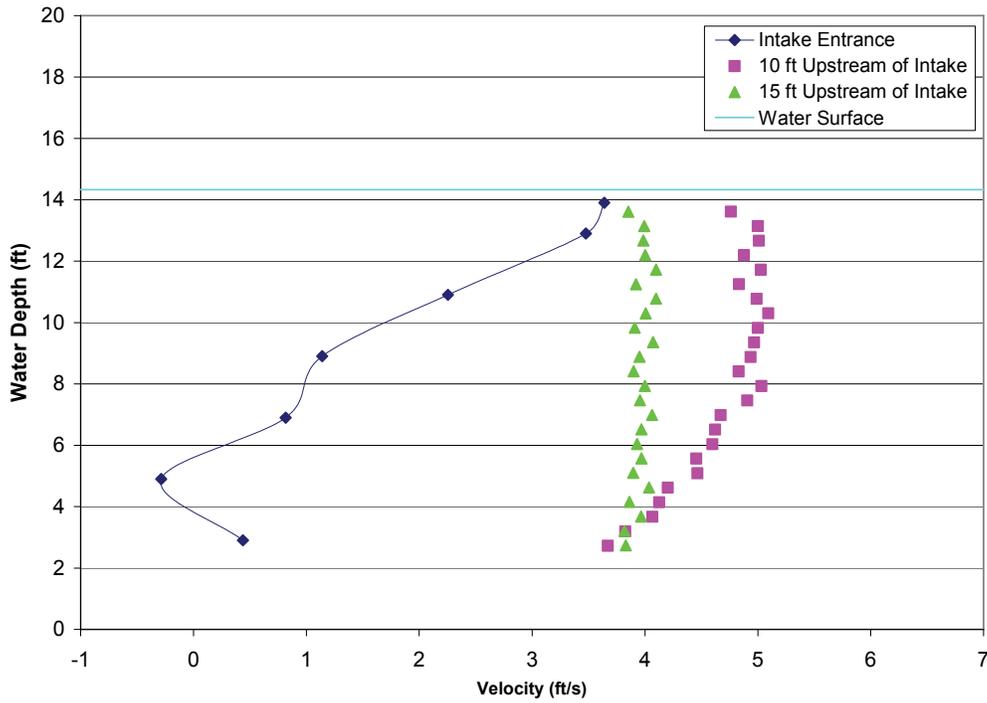
FIGURE A2-8.—Test 2-4, bypass 4 approach velocity profiles with all bypasses open, measured bypass ratio = 0.37, bypass ratio with facility instruments = N/A, outgoing tide, water depth = 14.33 ft, trashrack differential = 2.98 ft, louvers differential = 1.19 ft.

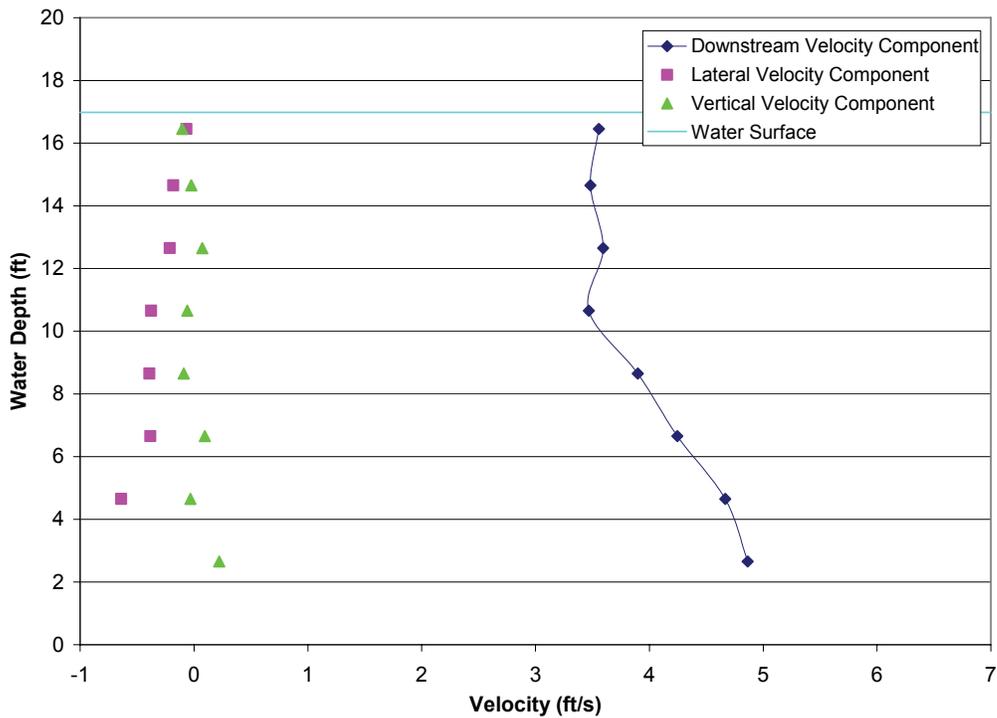
FIGURE A2-9.—Test 3-1, bypass 1 intake profile with all bypasses open, measured bypass ratio = 0.98, bypass ratio with facility instruments = 1.27, outgoing tide, water depth = 16.98 ft, trashrack differential = 0.94 ft, louvers differential = 0.45 ft.

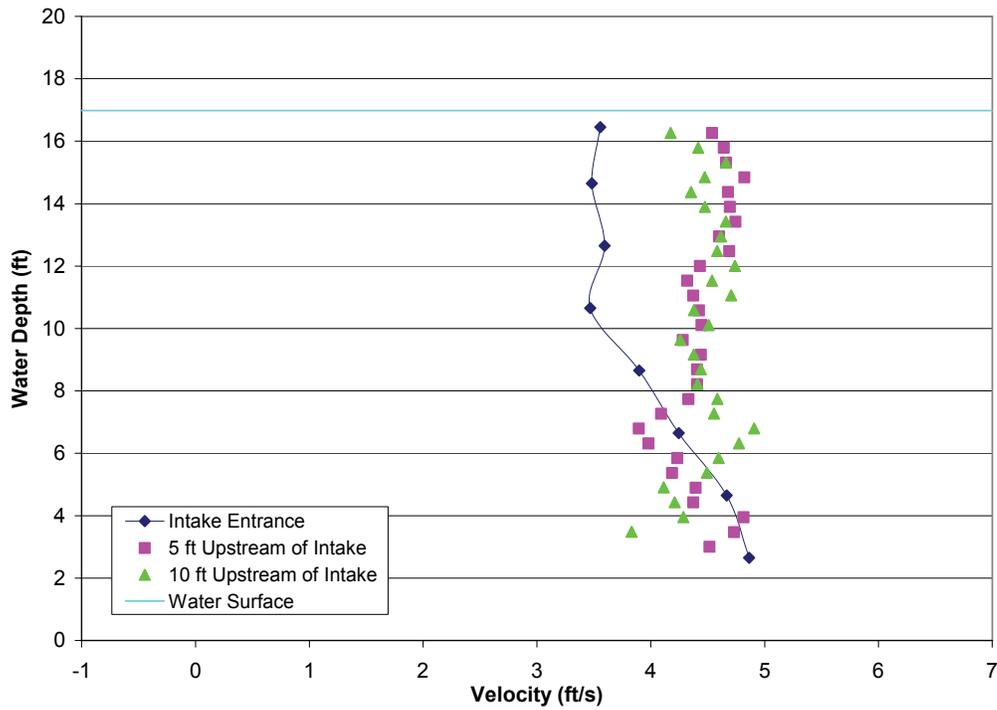
FIGURE A2-10.—Test 3-1, bypass 1 approach velocity profiles with all bypasses open, measured bypass ratio = 0.98, bypass ratio with facility instruments = 1.27, outgoing tide, water depth = 16.98 ft, trashrack differential = 0.94 ft, louvers differential = 0.45 ft.

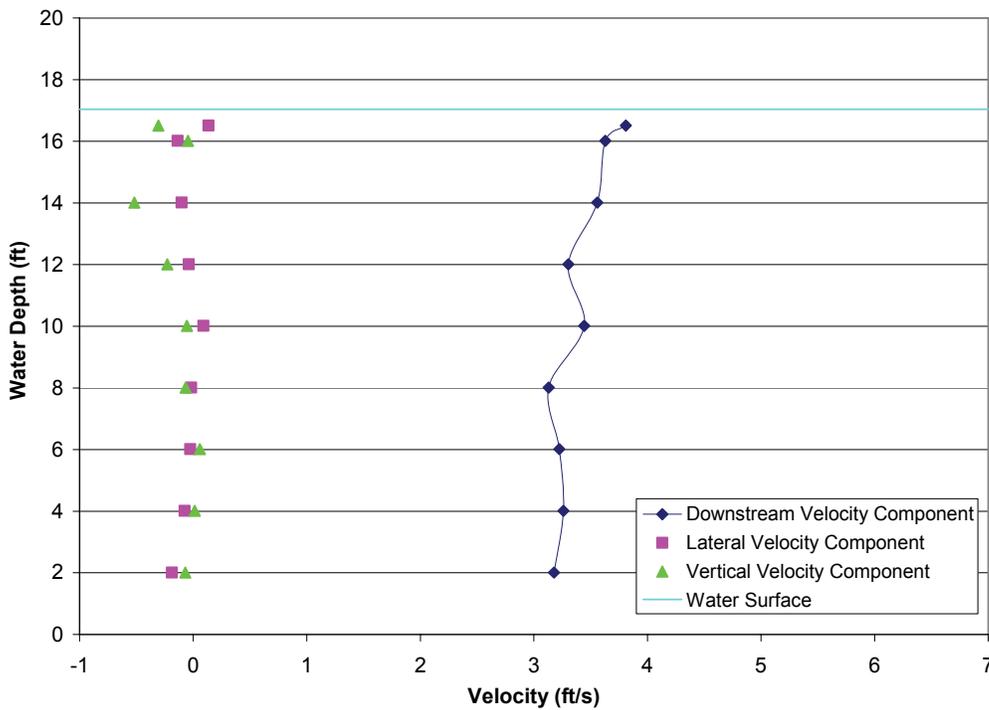
FIGURE A2-11.—Test 3-2, bypass 2 intake profile with all bypasses open, measured bypass ratio = 1.02, bypass ratio with facility instruments = 0.79, outgoing tide, water depth = 17.04 ft, trashrack differential = 1.11 ft, louvers differential = 0.55 ft.

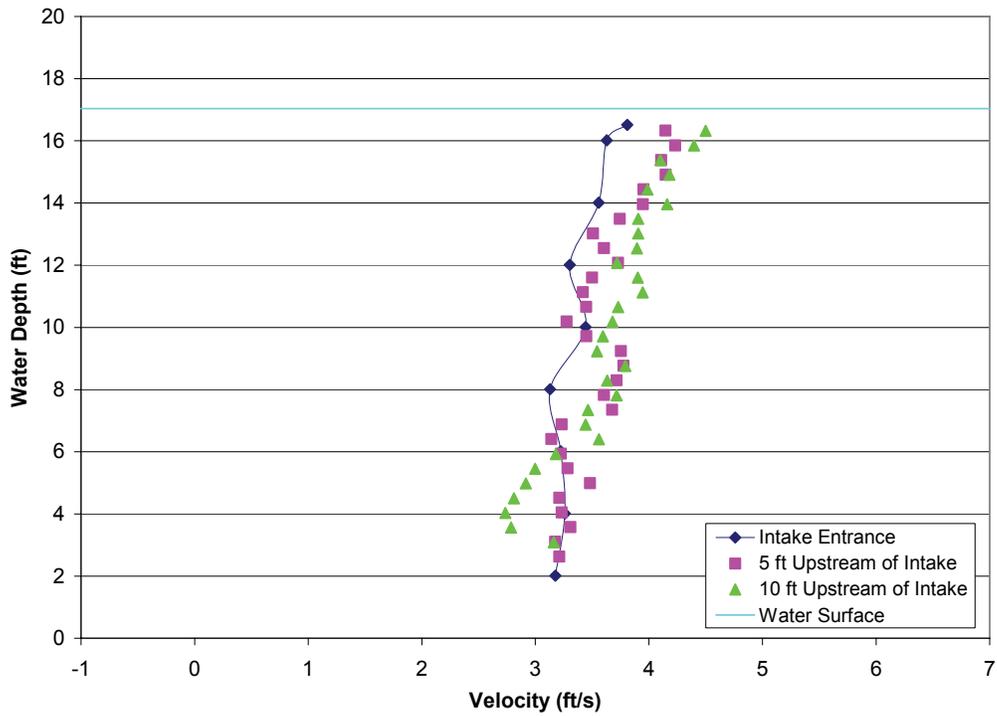
FIGURE A2-12.—Test 3-2, bypass 2 approach velocity profiles with all bypasses open, measured bypass ratio = 1.02, bypass ratio with facility instruments = 0.79, outgoing tide, water depth = 17.04 ft, trashrack differential = 1.11 ft, louvers differential = 0.55 ft.

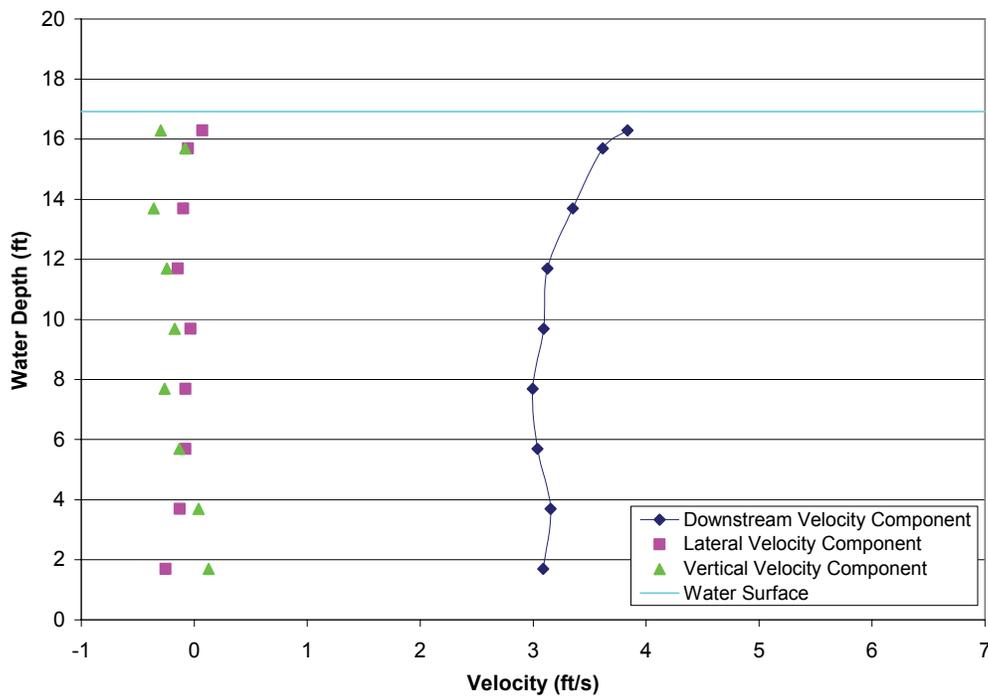
FIGURE A2-13.—Test 3-3, bypass 3 intake profile with all bypasses open, measured bypass ratio = 1.01, bypass ratio with facility instruments = 0.39, outgoing tide, water depth = 16.92 ft, trashrack differential = 1.27 ft, louvers differential = 0.44 ft.

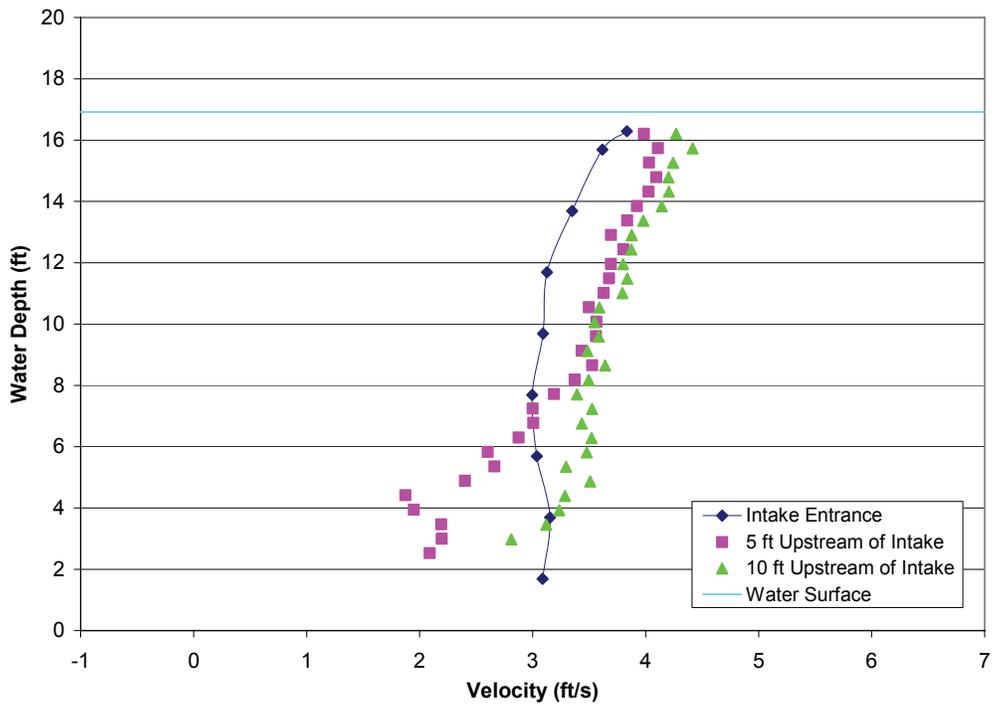
FIGURE A2-14.—Test 3-3, bypass 3 approach velocity profiles with all bypasses open, measured bypass ratio = 1.01, bypass ratio with facility instruments = 0.39, outgoing tide, water depth = 16.92 ft, trashrack differential = 1.27 ft, louvers differential = 0.44 ft.

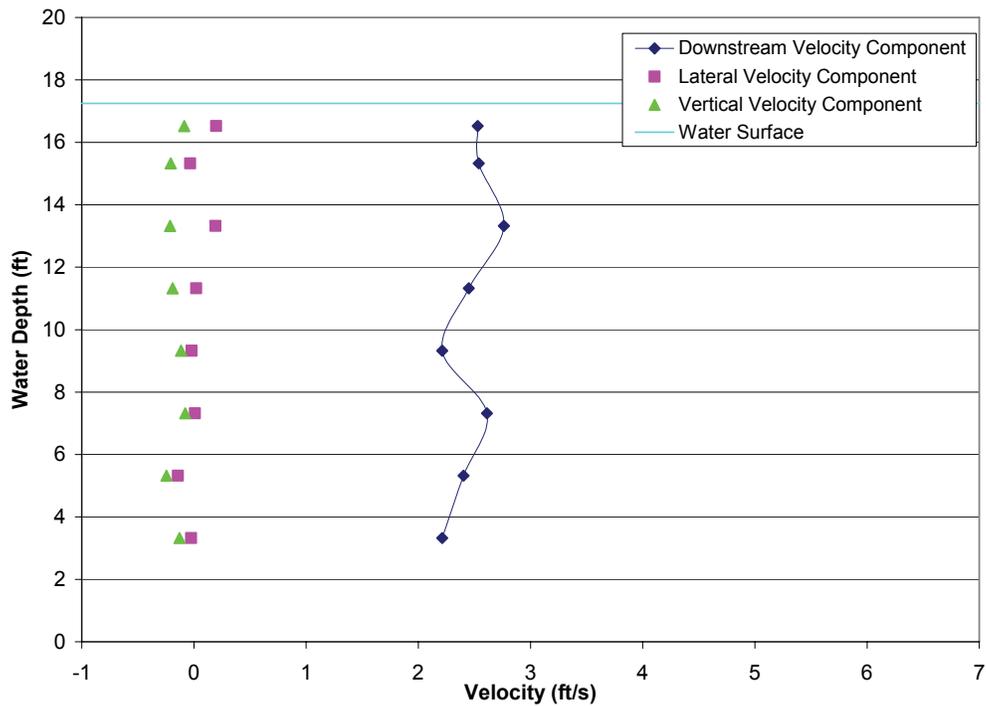
FIGURE A2-15.—Test 3-4, bypass 4 intake profile with all bypasses open, measured bypass ratio = 0.75, bypass ratio with facility instruments = 0.71, incoming tide, water depth = 17.25 ft, trashrack differential = 2.01 ft, louvers differential = 0.70 ft.

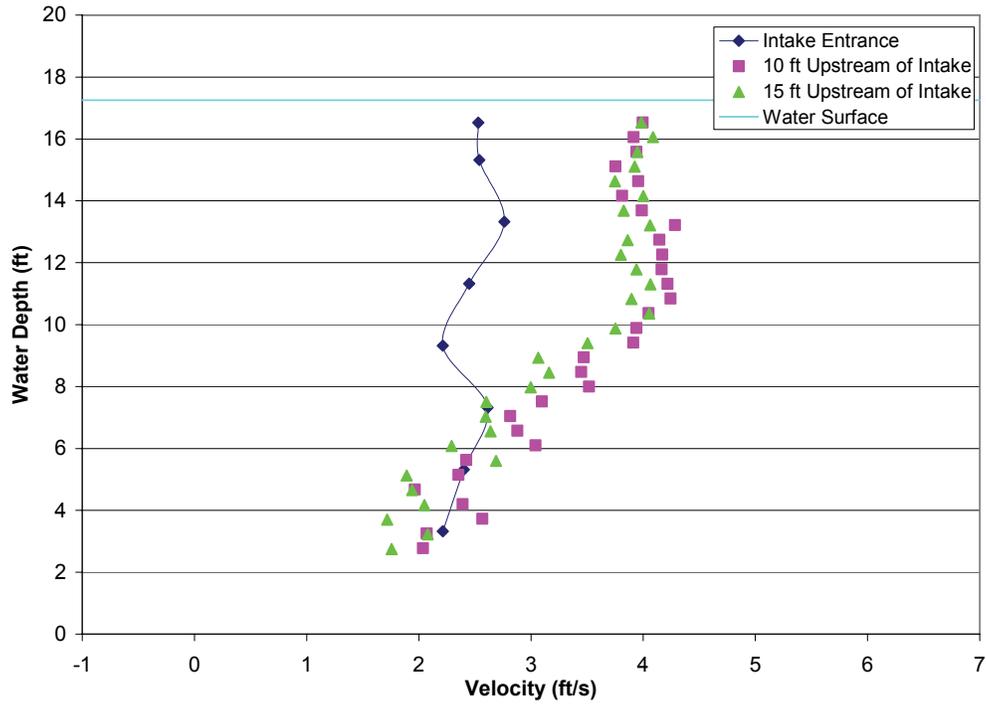
FIGURE A2-16.—Test 3-4, bypass 4 approach velocity profiles with all bypasses open, measured bypass ratio = 0.75, bypass ratio with facility instruments = 0.71, incoming tide, water depth = 17.25 ft, trashrack differential = 2.01 ft, louvers differential = 0.70 ft.

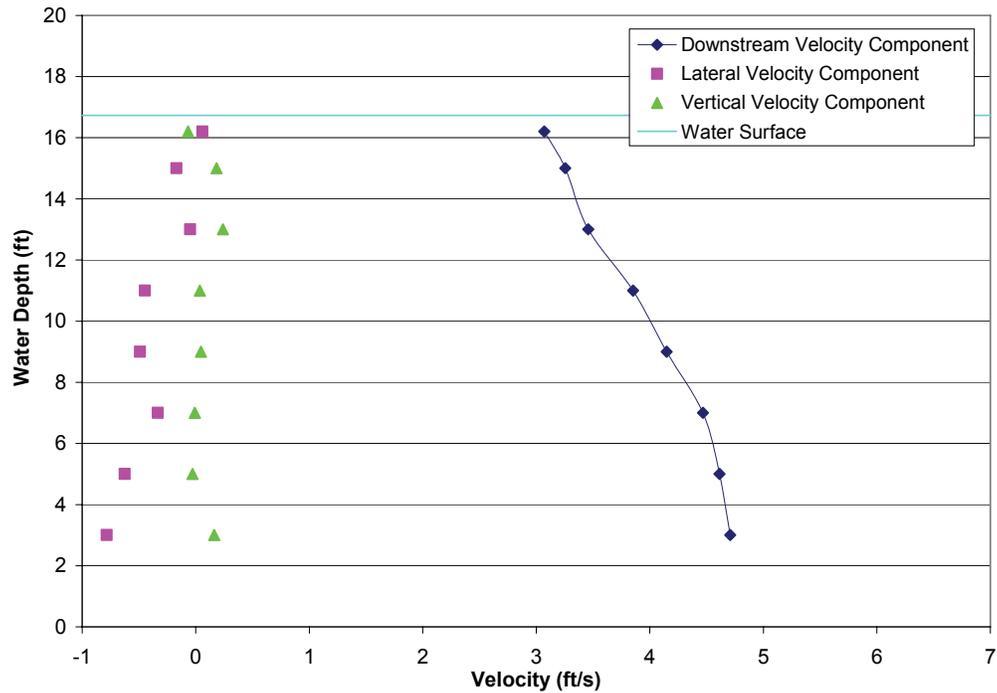
FIGURE A2-17.—Test 4-1, bypass 1 intake profile with all bypasses open, measured bypass ratio = 0.86, bypass ratio with facility instruments = 1.17, incoming tide, water depth = 16.73 ft, trashrack differential = 1.29 ft, louvers differential = 0.43 ft.

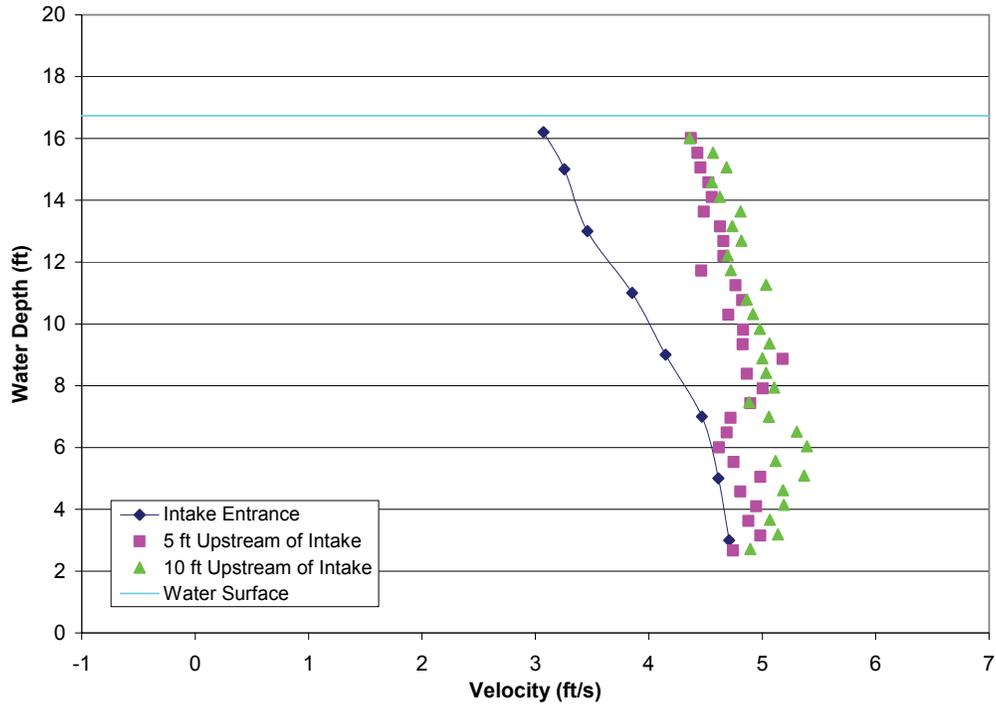
FIGURE A2-18.—Test 4-1, bypass 1 approach velocity profiles with all bypasses open, measured bypass ratio = 0.86, bypass ratio with facility instruments = 1.17, incoming tide, water depth = 16.73 ft, trashrack differential = 1.29 ft, louvers differential = 0.43 ft.

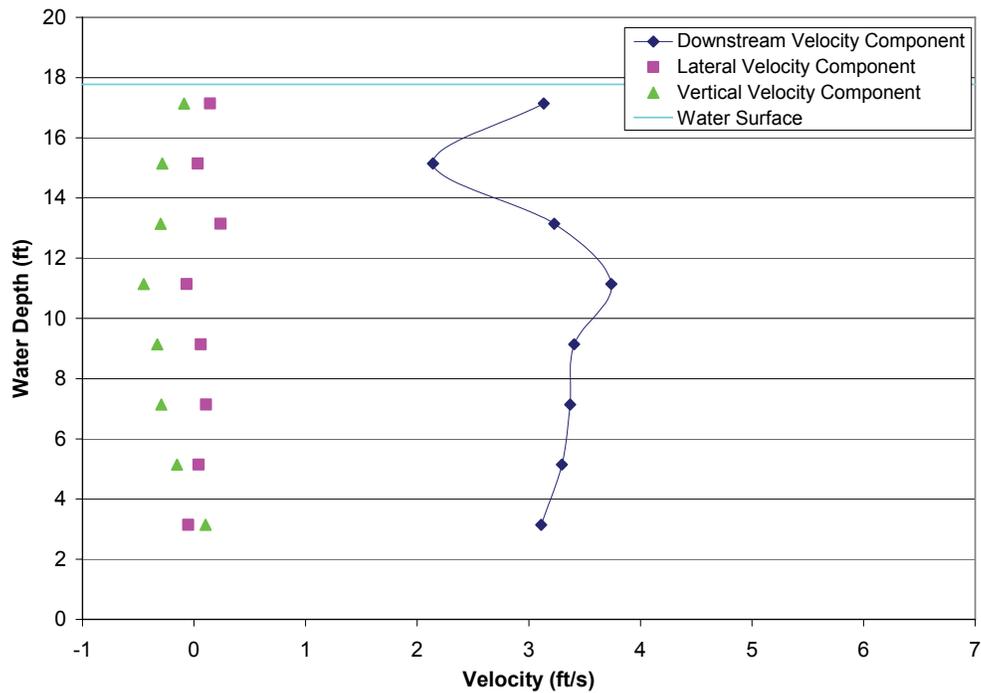
FIGURE A2-19.—Test 4-2, bypass 2 intake profile with all bypasses open, measured bypass ratio = 0.84, bypass ratio with facility instruments = 0.72, incoming tide, water depth = 17.77 ft, trashrack differential = 1.35 ft, louvers differential = 0.62 ft.

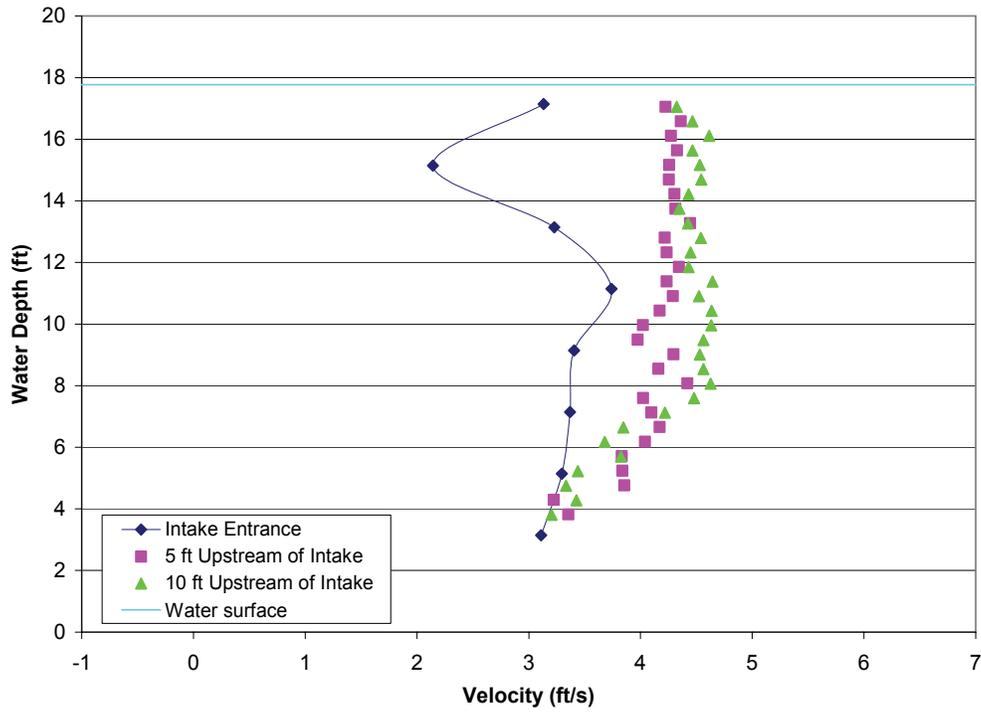
FIGURE A2-20.—Test 4-2, bypass 2 approach velocity profiles with all bypasses open, measured bypass ratio = 0.84, bypass ratio with facility instruments = 0.72, incoming tide, water depth = 17.77 ft, trashrack differential = 1.35 ft, louvers differential = 0.62 ft.

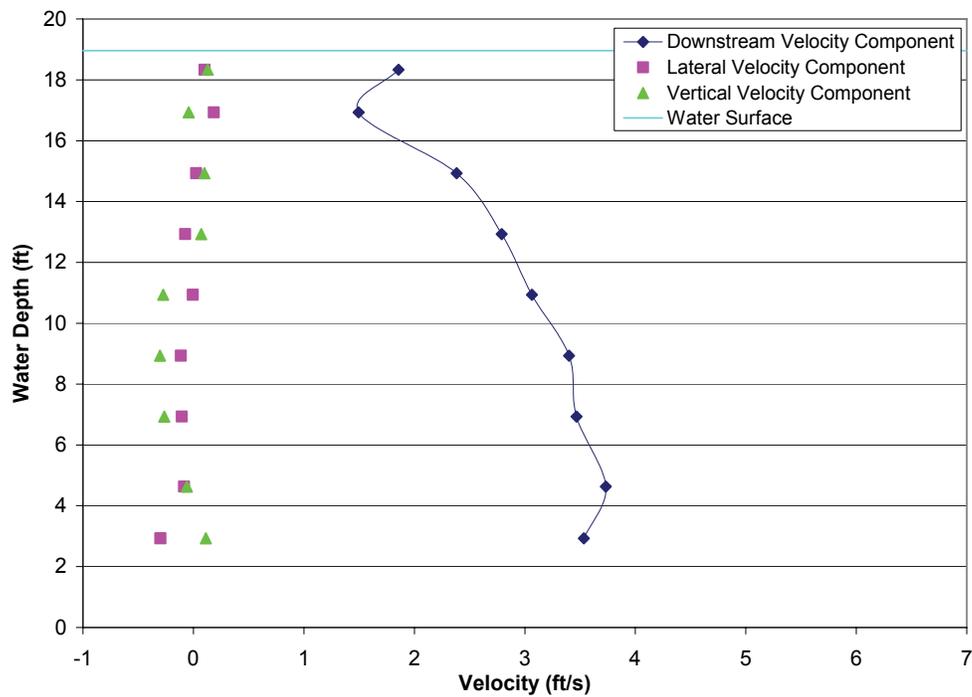
FIGURE A2-21.—Test 4-3, bypass 3 intake profile with all bypasses open, measured bypass ratio = 0.98, bypass ratio with facility instruments = 0.74, incoming tide, water depth = 18.96 ft, trashrack differential = 1.07 ft, louvers differential = 0.37 ft.

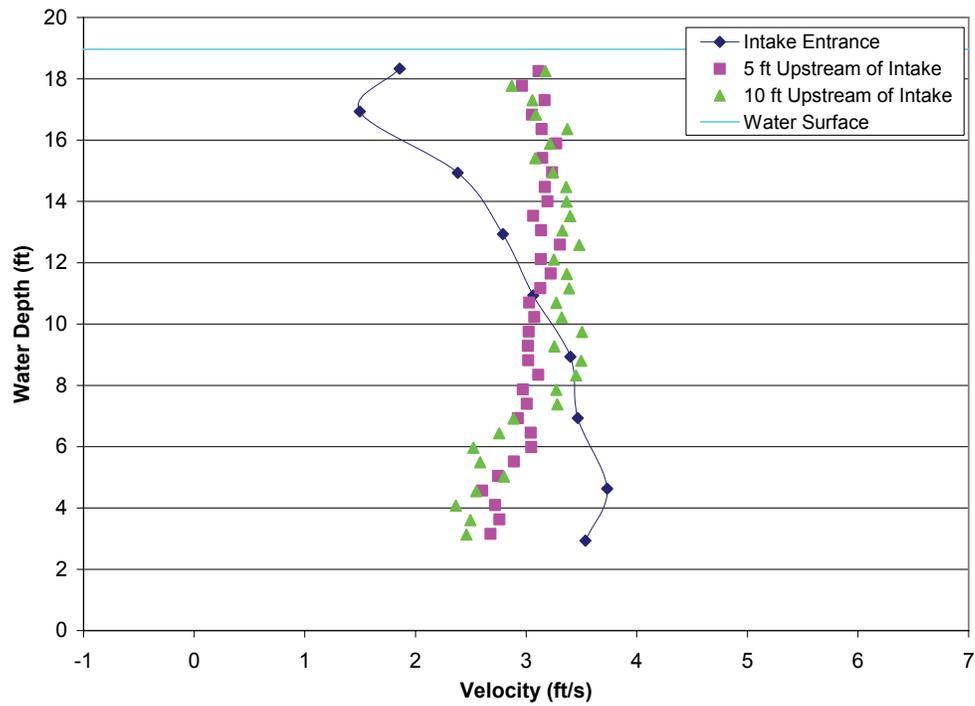
FIGURE A2-22.—Test 4-3, bypass 3 approach velocity profiles with all bypasses open, measured bypass ratio = 0.98, bypass ratio with facility instruments = 0.74, incoming tide, water depth = 18.96 ft, trashrack differential = 1.07 ft, louvers differential = 0.37 ft.

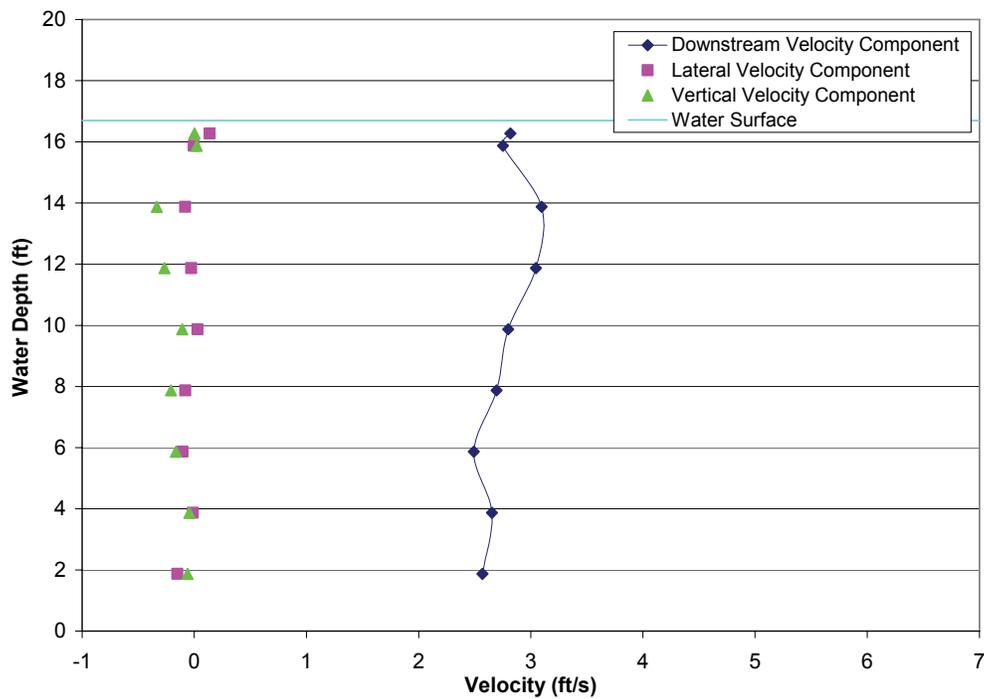
FIGURE A2-23.—Test 4-4, bypass 4 intake profile with all bypasses open, measured bypass ratio = 0.87, bypass ratio with facility instruments = 0.90, high tide, water depth = 16.70 ft, trashrack differential = 1.27 ft, louvers differential = 0.49 ft.

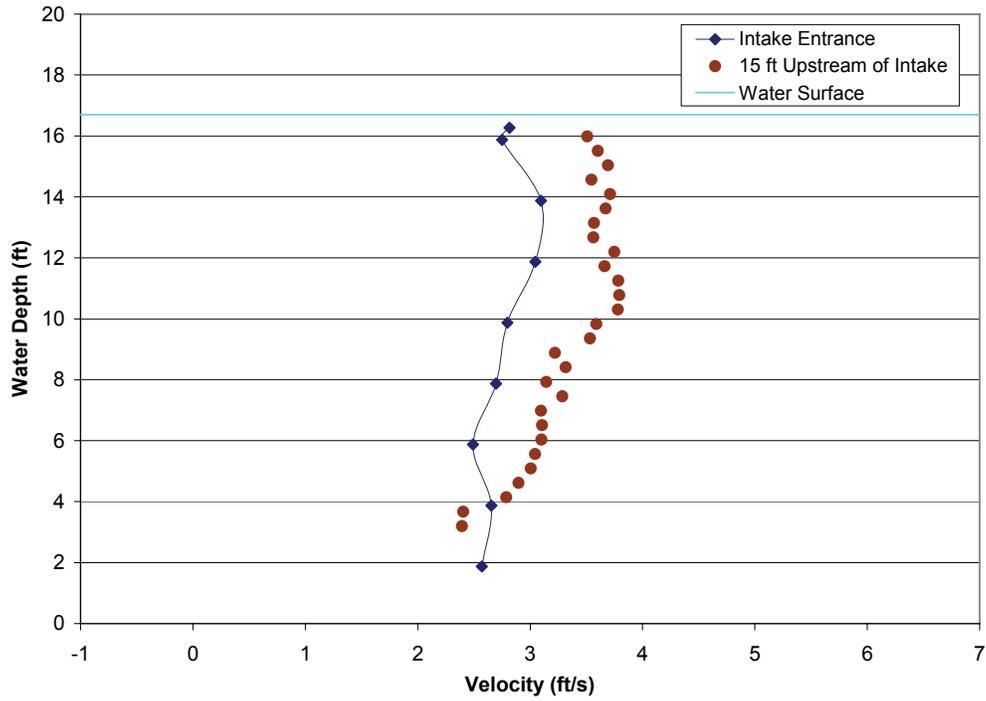
FIGURE A2-24.—Test 4-4, bypass 4 approach velocity profiles with all bypasses open, measured bypass ratio = 0.87, bypass ratio with facility instruments = 0.90, high tide, water depth = 16.70 ft, trashrack differential = 1.27 ft, louvers differential = 0.49 ft.

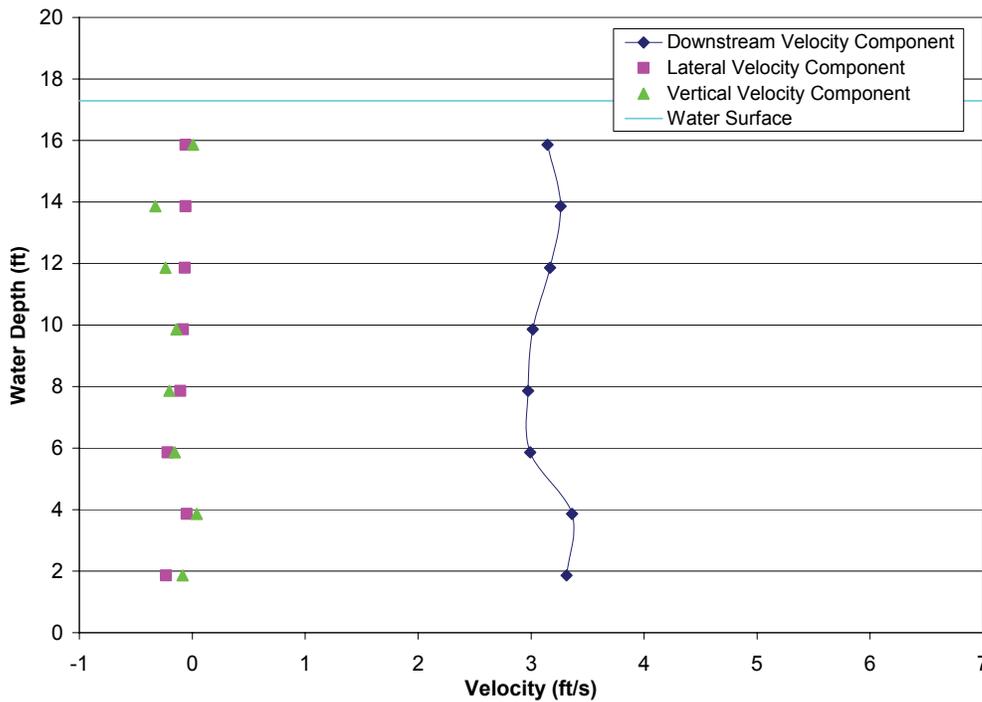
FIGURE A2-25.—Test 1A, bypass 4 intake profile with all bypasses open, measured bypass ratio = 1.05, bypass ratio with facility instruments = 1.02, outgoing tide, water depth = 17.29 ft, trashrack differential = 1.06 ft, louvers differential = 0.45 ft.

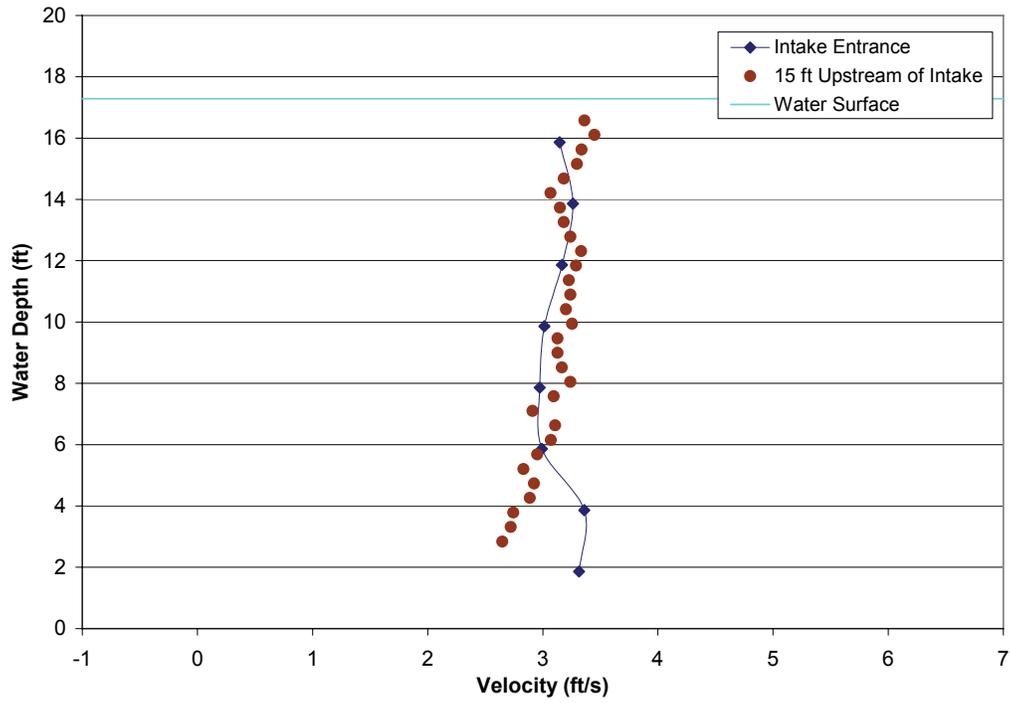
FIGURE A2-26.—Test 1A, bypass 4 approach velocity profiles with all bypasses open, measured bypass ratio = 1.05, bypass ratio with facility instruments = 1.02, outgoing tide, water depth = 17.29 ft, trashrack differential = 1.06 ft, louvers differential = 0.45 ft.

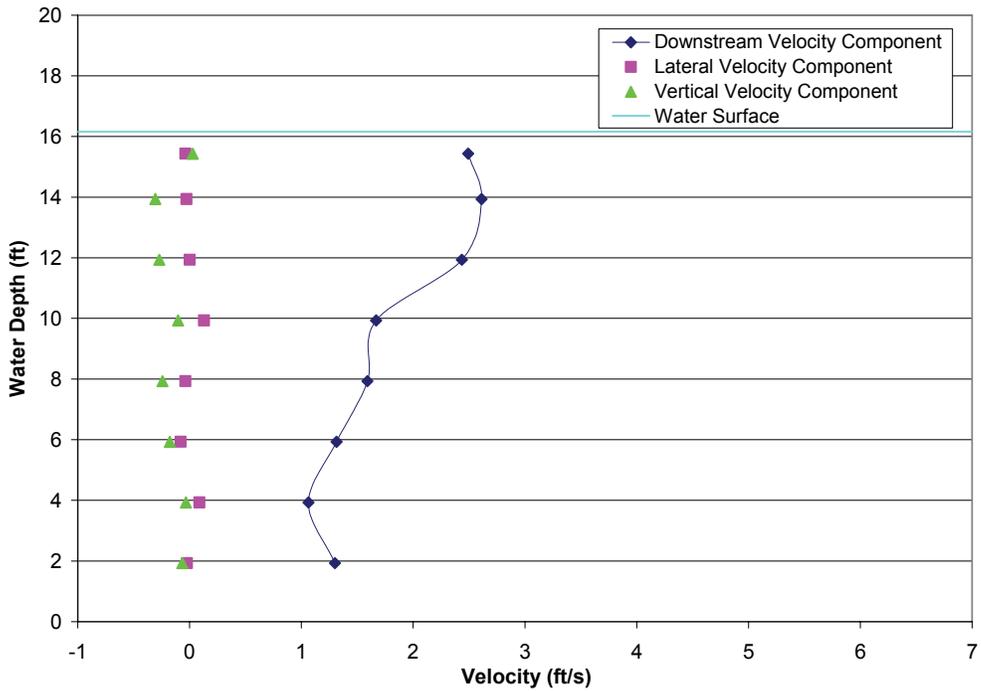
FIGURE A2-27.—Test 1B, bypass 4 intake profile with bypass 1 closed, measured bypass ratio = 0.61, bypass ratio with facility instruments = 0.64, outgoing tide, water depth = 16.16 ft, trashrack differential = 1.50 ft, louvers differential = 0.51 ft.
